STRUCTURE NO. 1 - LITTLE SNI-A-BAR CREEK  
LAFAYETTE COUNTY, MISSOURI  
MO 10480

PHASE 1 INSPECTION REPORT  
NATIONAL DAM SAFETY PROGRAM

PREPARED BY: HOSKINS-WESTERN-SONDEREGGER, INC.  
FOR: STATE OF MISSOURI

SEPTEMBER, 1978

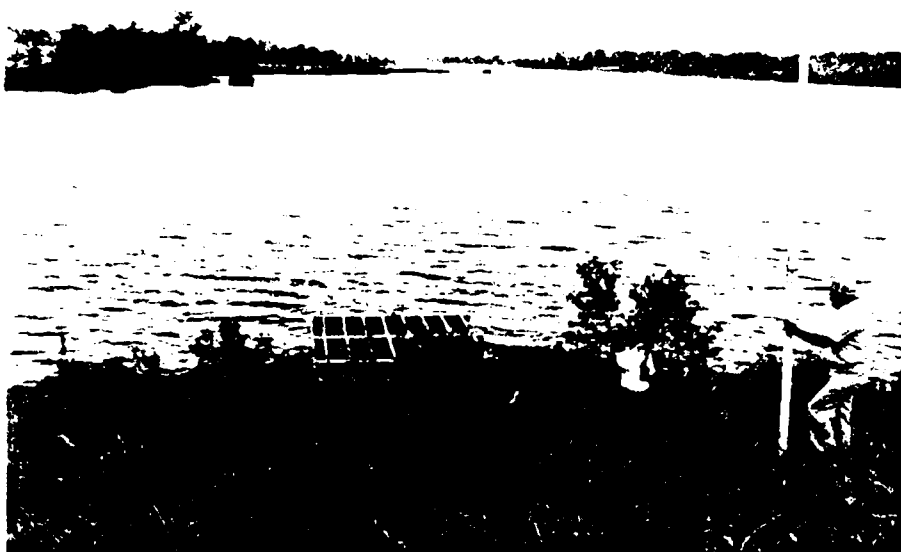
- (1) Principal spillway. There were no indications of spalling or deterioration of the principal spillway riser nor the concrete pipe outlet. The lake level was just below (0.1 ft.) the crest elevation of the spillway at the time of the inspection. A number of logs and tree branches, up to 6 inches in diameter, were lodged around the trash rack of the spillway.

PHOTO. NO. 8  
LOOKING UPSTREAM  
AT PRINCIPAL  
SPILLWAY RISER.

- (2) A program of regular maintenance and inspection should be initiated. This program should be designed to control vegetation on the dam, keep the principal spillway open and repair rodent holes and rill erosion on the slopes of the dam.
